Manhole Inspection Summary

Manhole # S41U1_008MH

Insp Date: **12/3/07 12:44 PM**

Location Address: **601 Chesapeake Ave**

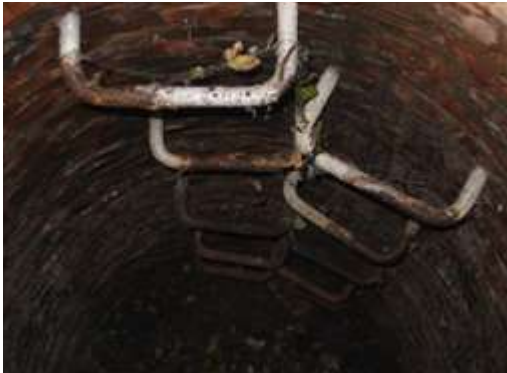
steps

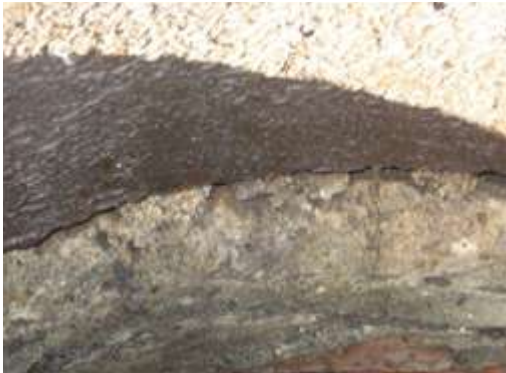
Defect 1

frame offset

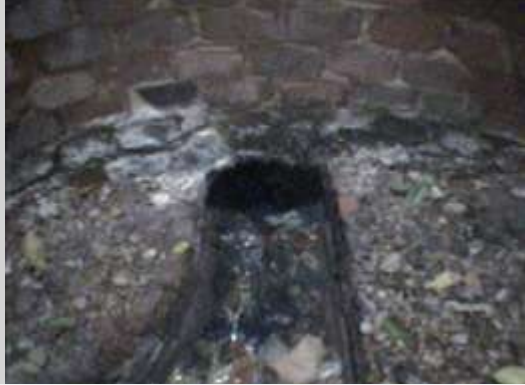
12 O'Clock Outflow

8 in. Circular Gravity Sewer
Pipe Out @ 12 O'Clock

Pipe Height: **9.6** (in.) Rod and Bar (Angled)
Pipe Material: **Clay** ☐ Pipe Lined
Invert Depth: **16.96** (ft.) Flow Characteristics: **Slow**
Deposits: ☒ None ☐ Mud ☐ Sludge ☐ Debris ☐ Grease
Silt Depth: (in.) Deposits Extent:
Infiltration: **None** Pipe Seal Cond: **Sound**

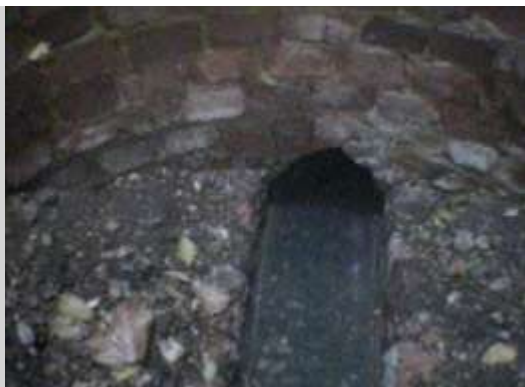
6 O'Clock Inflow

8 in. Circular Gravity Sewer
Pipe In @ 6 O'Clock

Pipe Height: **10.8** (in.) Rod and Bar (Angled)
Pipe Material: **Clay** ☐ Pipe Lined
Invert Depth: **16.94** (ft.) Flow Characteristics: **Slow**
Deposits: ☒ None ☐ Mud ☐ Sludge ☐ Debris ☐ Grease
Silt Depth: (in.) Deposits Extent:
Infiltration: **None** Pipe Seal Cond: **Sound**

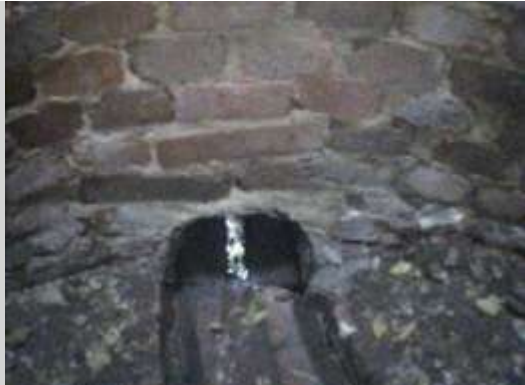
9 O'Clock Inflow

Pipe In @ 9 O'Clock

Pipe Height: **9.6** (in.) Rod and Bar (Angled)

Infiltration: **None** Pipe Seal Cond: **Sound**

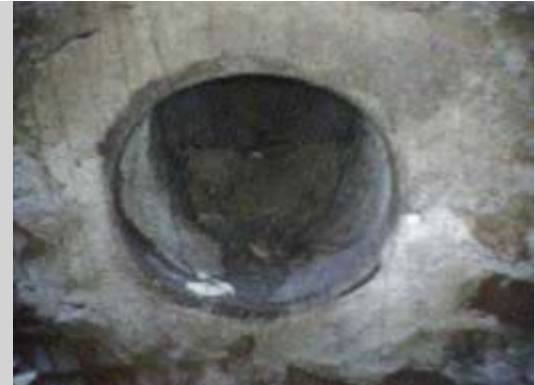
Drop In @ 9 O'Clock

Drop: **Outside** Rod and Bar

Angled: **Yes** Reading: **15.70** (ft.)

Inv Depth: **16.70** (ft.)

Drop Condition: **Open**
